# **INTERNATIONAL EXPO MASTER COURSE ON COASTAL-MARINE INTEGRATED MANAGEMENT**

**Academic year 2013-2014**

**Pre-feasibility study for application of a beach certification  
scheme on river bathing areas in the State of Meta, Colombia**

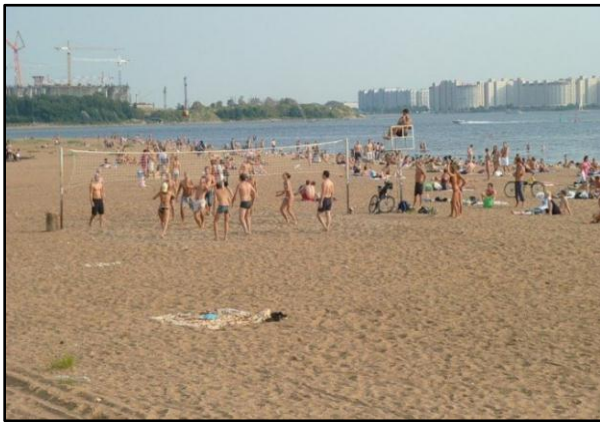
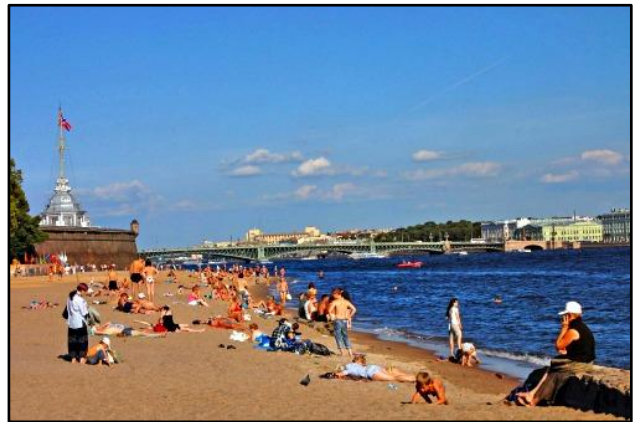
**Figure 3 The urban beach of Neva River**, next to the Peter and Paul Fortress in St. Petersburg (Russia). The beach is currently not in a very good environmental condition. The water quality is not sufficient for bathing, but the beach provides space for variety of leisure activities. Pictures: <http://www.petersburg-lodging.com/st-petersburg-russia-pictures>

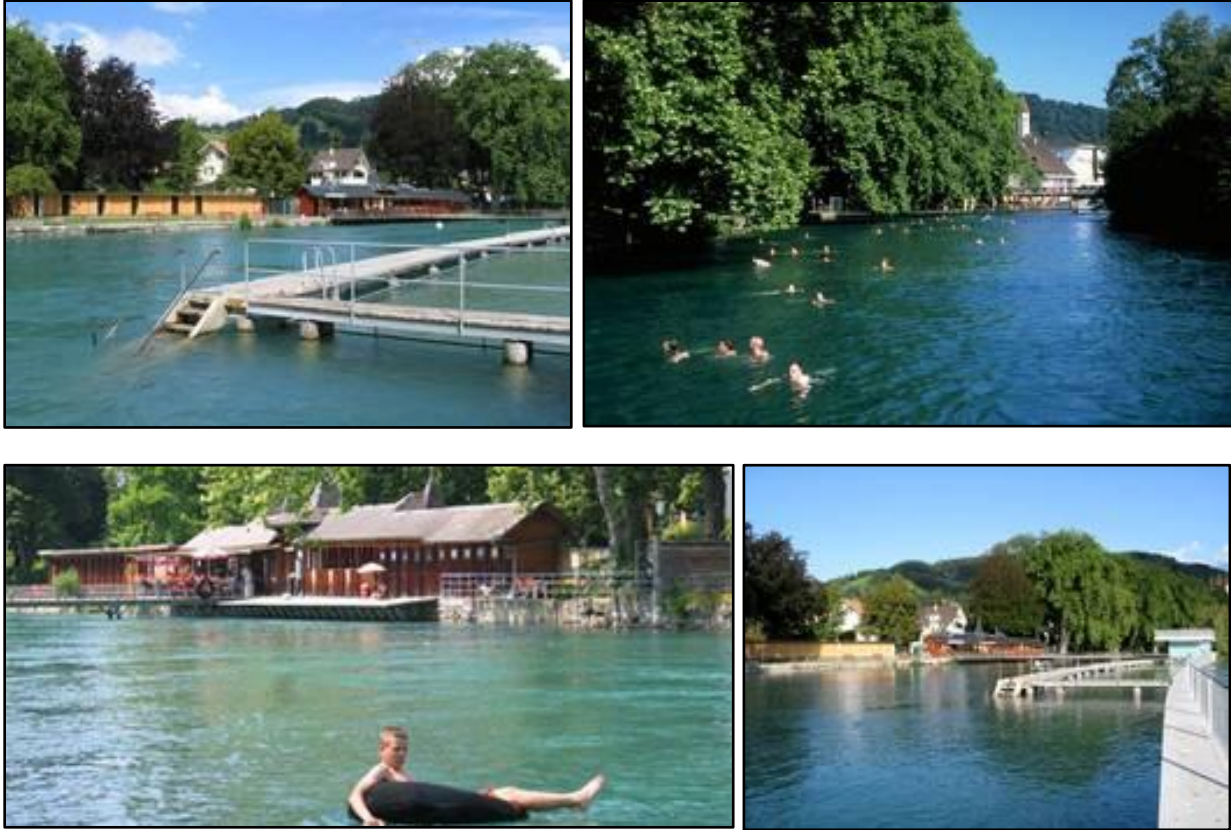
**Figure 4 Natural/historical river bathing area on Schwäbis River in Switzerland.** The bathing area was constructed in 1869/70 and renovated in 2006. The infrastructure includes a restaurant, changing rooms and access for handicapped people. The main role of this bathing area is to provide support for the main historical and natural attractions in the area. Pictures: [www.thun.ch](http://www.thun.ch)

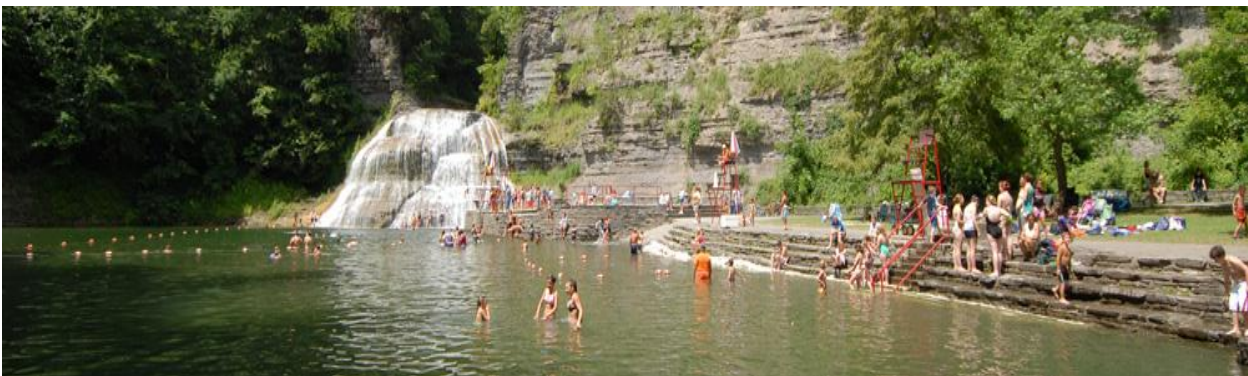
**Figure 5 Natural river bathing area at Robert H. Treman State Park, Ithaca, NY (USA).** It is a State Park that established the swimming area that includes lifeguarding service. The natural areas can provide high level of experience due to the beauty of landscape formations and clean waters. Picture: John Rozell / NYS Parks

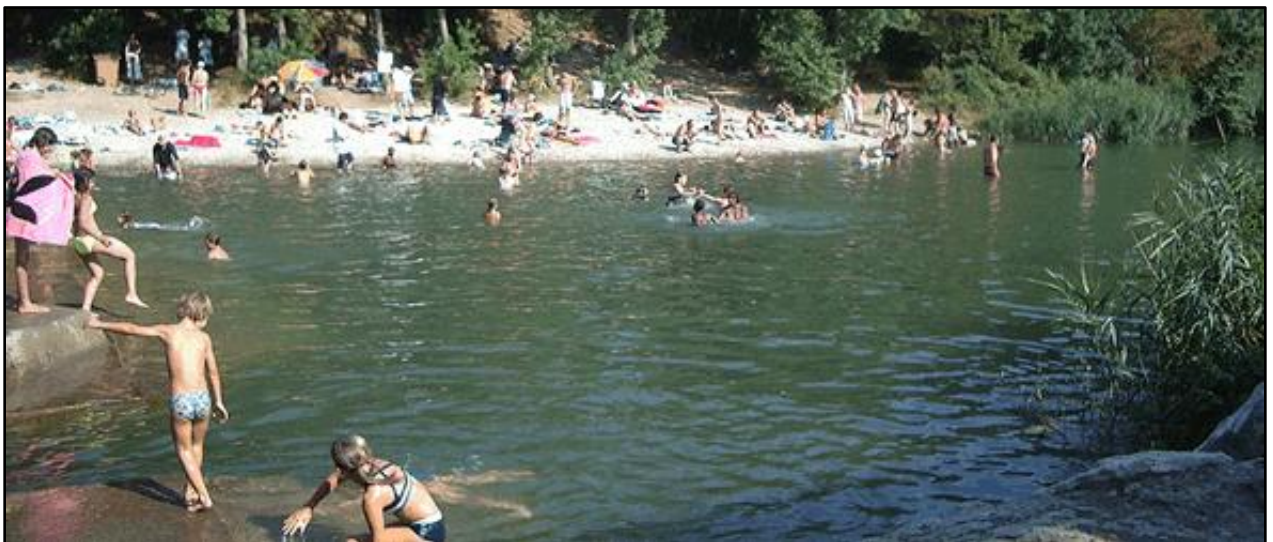
**Figure 7 River bathing area in Lagrasse village, France.** The river flows through the center of the village. During the summer season the river is dammed to increase its water level. Picture: <http://www.creme-de-languedoc.com/>

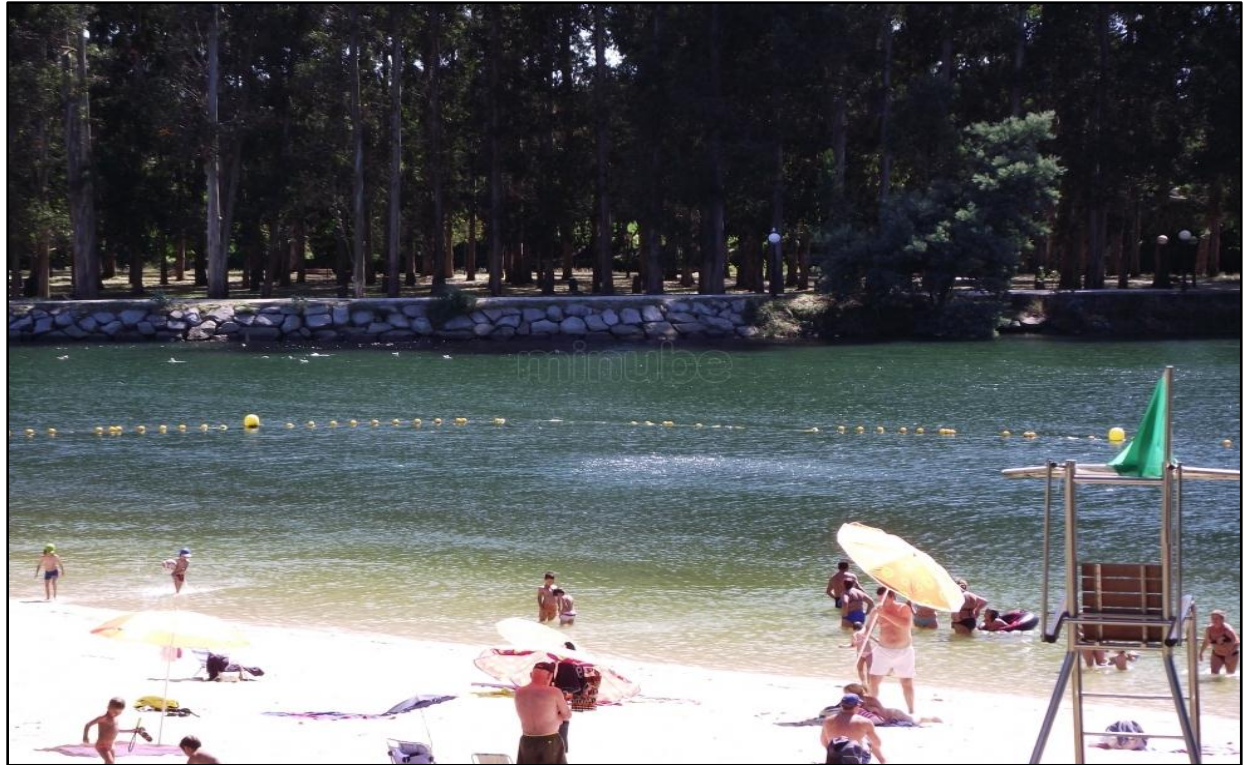
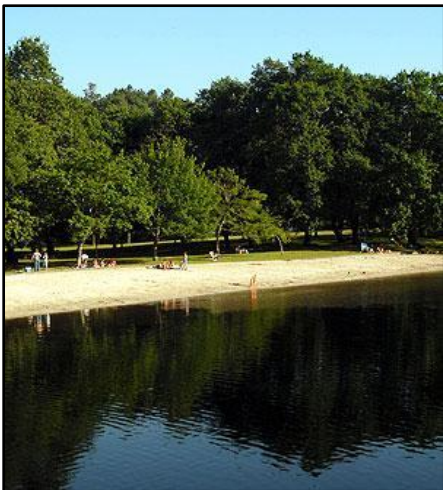
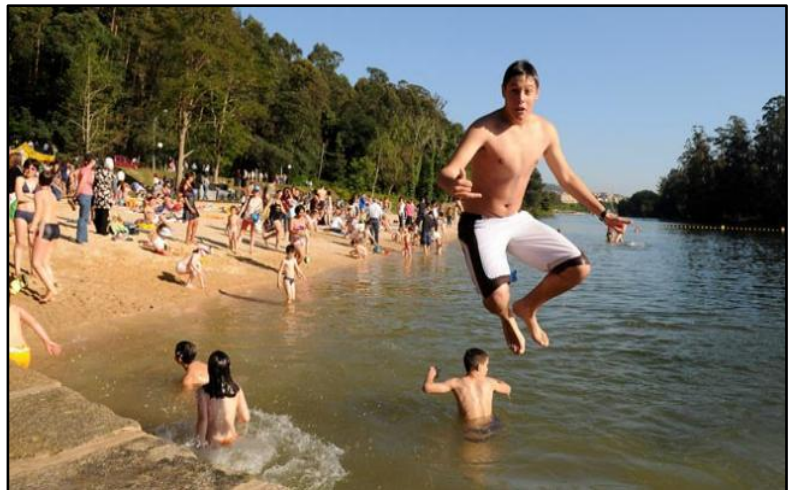
**Figure 9 Pontevedra Beach on Lerez River - the only river bathing area striving for Blue Flag.**

There is only one river beach that will apply for the Blue Flag in 2014 (Image xxx). The beach is located on the Leréz River in city of Pontevedra in Spain. The bathing area was established in 2009 and quickly became the favorite place for people from the area. The beach is located 3km from the mouth of Lerez River. Currently there is presence of life guards, systematic water quality measurement that has been carried out for years now and many other facilities that help take the beach to the certification level in 2014.

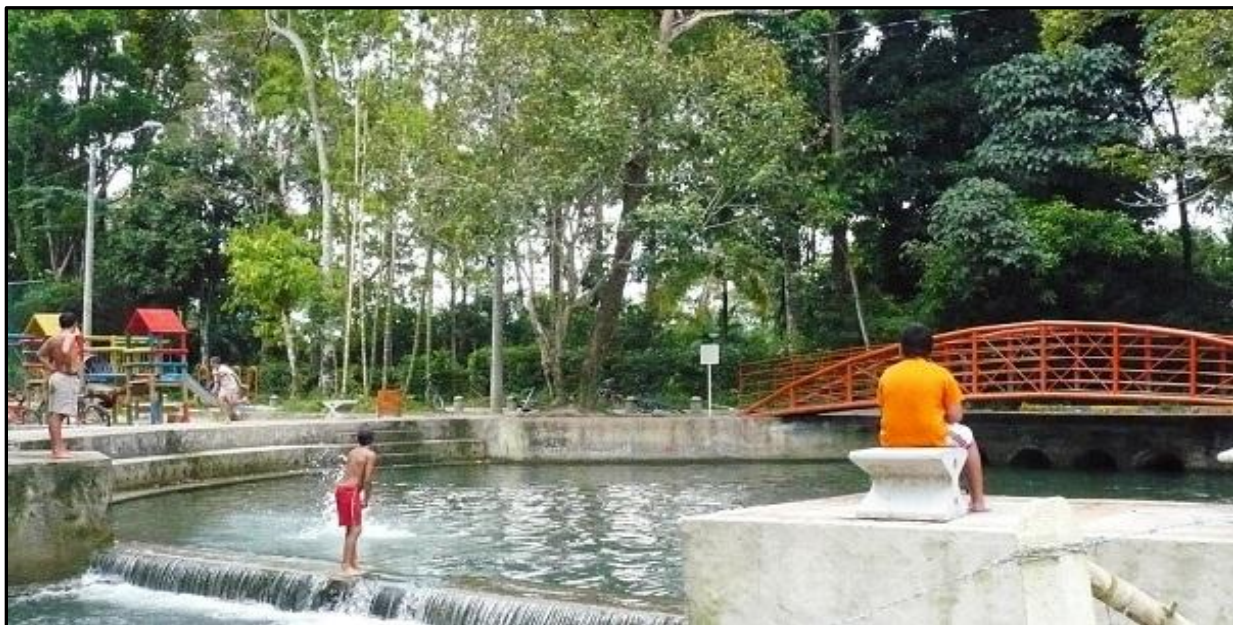
**Figure 15 Bathing area Caycal, Meta**

Located 7.6km from the center of a municipal city is a recreation area that has a park, small football field and beach volleyball field. The bathing area is made through damming a small creek creating an artificial swimming pool channeled by concrete walls. The water is supplied by an bypass system that takes water from the river that flow to the swimming basin and then again flow back to the river. This is a very typical system that can be found in many small bathing areas. Although the surroundings is very natural and in good environmental condition (little anthropic inference), the concrete infrastructure was built with donation from the local municipality and receives very little maintenance. In consequence, the deterioration can be clearly seen.

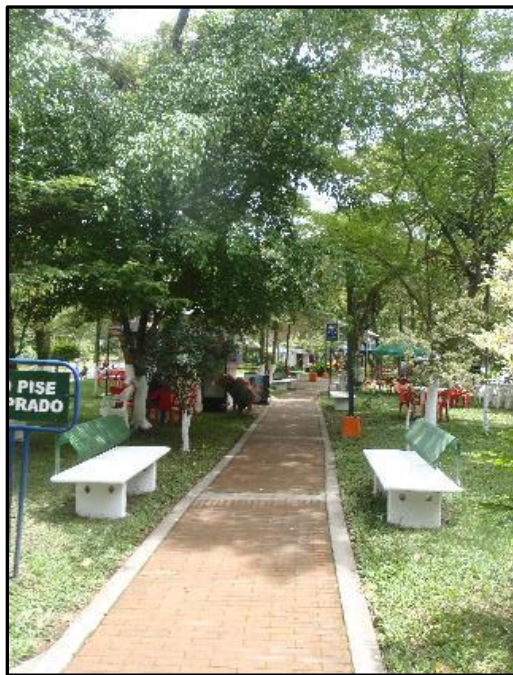
**Figure 16 Supporting infrastructure at "El Malecon" bathing area**

“El Malecon” is a river bathing area that has received most attention from the local municipality and in results it has been developed receiving paved beach front and basic infrastructure that includes park, outdoor sport facilities, public toilets, proper signage, garbage bins and parking lots. Very soon a variety of restaurants and kiosks were built to offer food and beverage to the visitors.

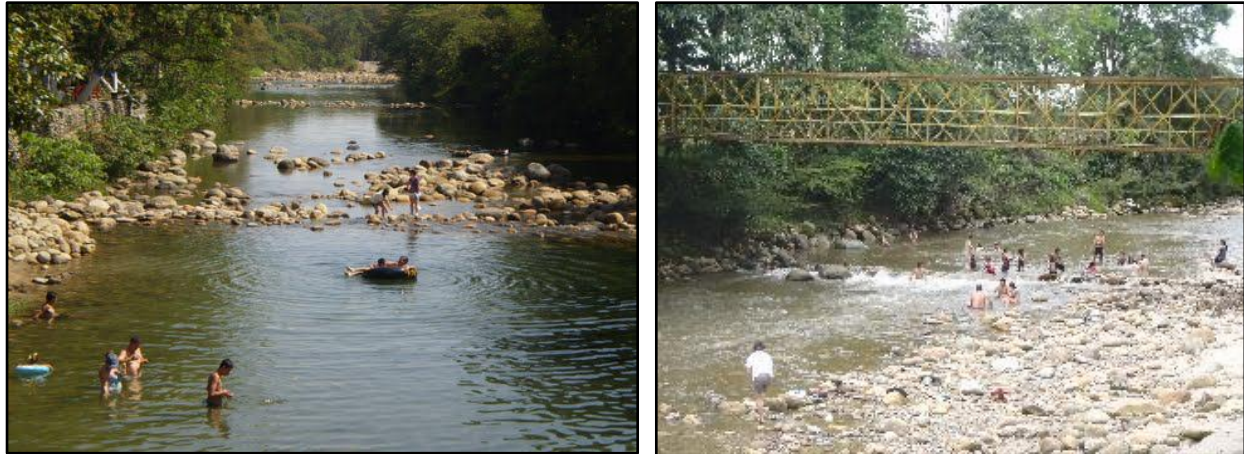
**Figure 17 El Malecon during high tourist season (dammed) and low tourist season (shallow water full of river material)**

Although the river is rather shallow, the bathing zone is created during high tourist season (December – February), which is also the dry season, through damming downstream using the stones dredged from the bathing area. In this way the dam increases the water level, while dredged stones taken from the river bed increase its depth. Normally, created in this way bathing zone is maintained throughout the year, slowly losing the depth, because after heavy rains the current is strong enough to destroy the dam and carry lots of material back to the bathing zone.

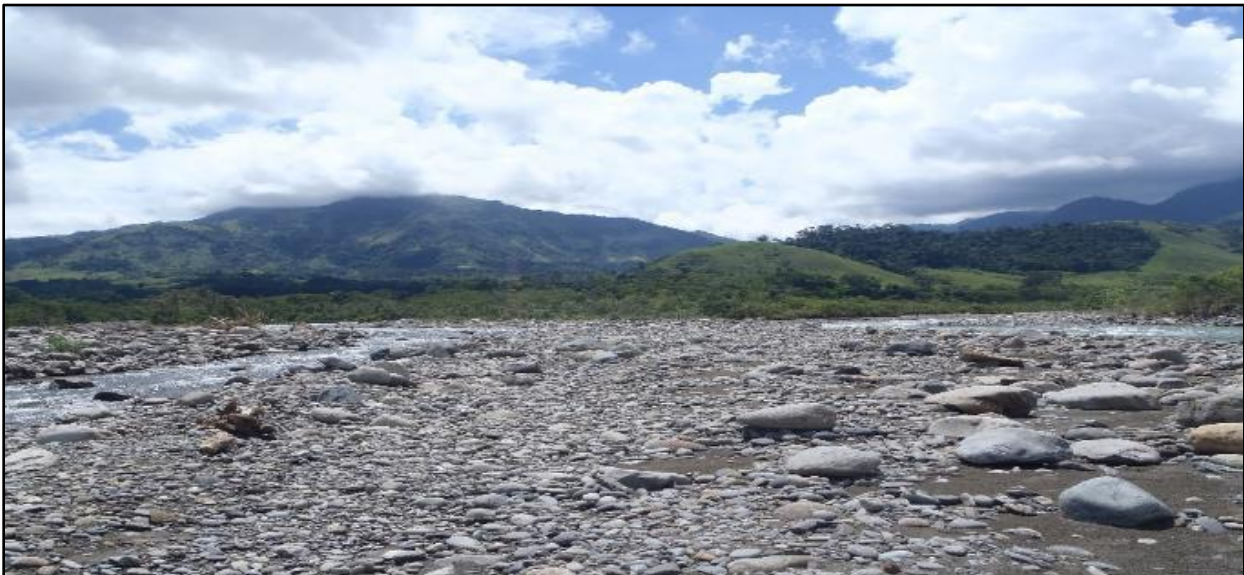
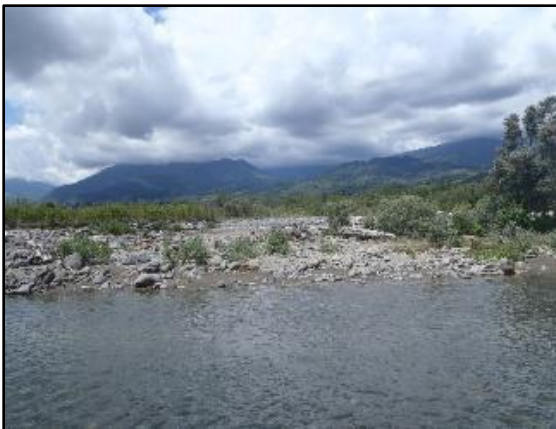
**Figure 18 (above and under) Puente Amistad natural bathing area that is affected by seasonal variations of water supply**

This natural (wild swimming) bathing area is located 2.4km from the municipal city of Cubarral. There are no facilities around the area, but the natural setting of the river is stunning, also due to the fact that various rivers that carry crystal water of different colors enter the main river here. The river is known for white water rafting during most of the year except the dry summer season. During the dry season the river flow is much weaker (Figure 18), so is the water depth that does not allow swimming.

The proximity of the mountains that receive a lot of rain and high angle of rivers are the main cause of fast currents. During the rainy season the flow is so big that the whole area turn to a river that carries heavy stones, which can be seen on the picture above. In consequence, when the flow decreases, very often the rivers find completely new bed to flow, different from the last one. This can happen various times even during the same season.

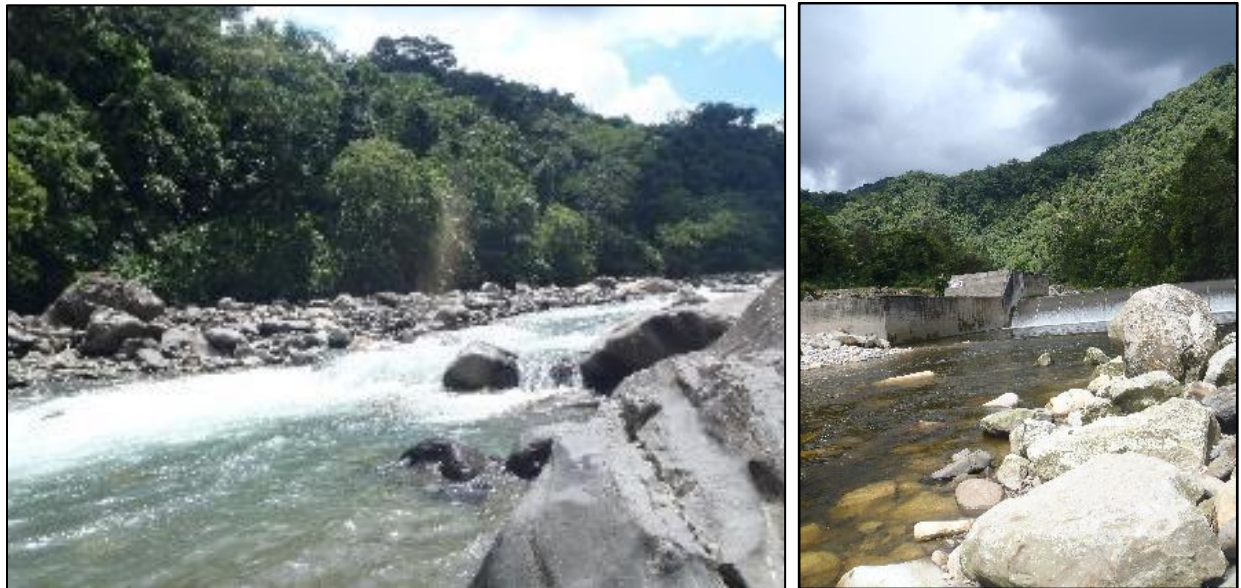
**Figure 19 Puente la Libertad and Bocatoma aguas Claras natural bathing areas**

These two mountain type natural (wild) river bathing areas can be described together as they both have very similar characteristics. They are located in remote areas, although not far from the municipal city, in the same mountain range. Since they are mountainous rivers, the water quality is very good, but because of high angle of the river flow the current is strong, thus dangerous for swimmers. The number of large stones and the river bed generate vortexes and rapids that even further decreases safety of the bathers. While at “Puente la Libertad” once can find small sandy beaches full of golden yellow medium grain size sand, “Bocatoma Aguas Claras” is located very close downstream from a large dam, thus there is very little sediment on the river bed.

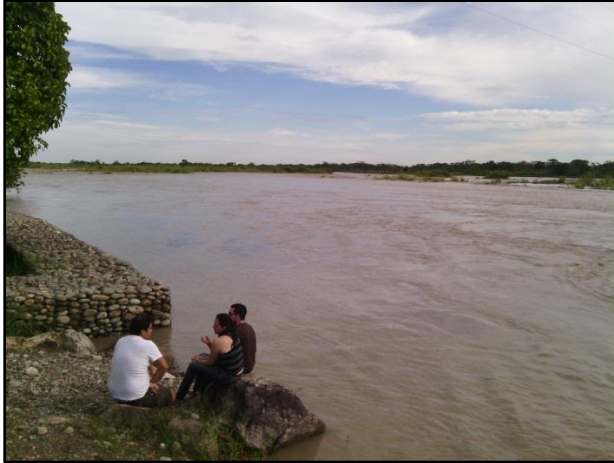
**Figure 20 Alcaravan bathing area during rainy season**

This bathing area is located 15.1km from the municipality of Granada. It is well known and well established bathing area with basic infrastructure such as restaurants, toilet, and changing rooms. The particularity of this bathing area is characterized by extreme water level change between the dry and wet seasons. During the dry season there are plenty of sandy beaches visible along the river (Figure 21), while during the rainy season the river receives water from many sources thus its quality is low. Moreover during rainy days the level of water is high enough to cover the beaches (Figure 20), although it is still quite safe to swim.

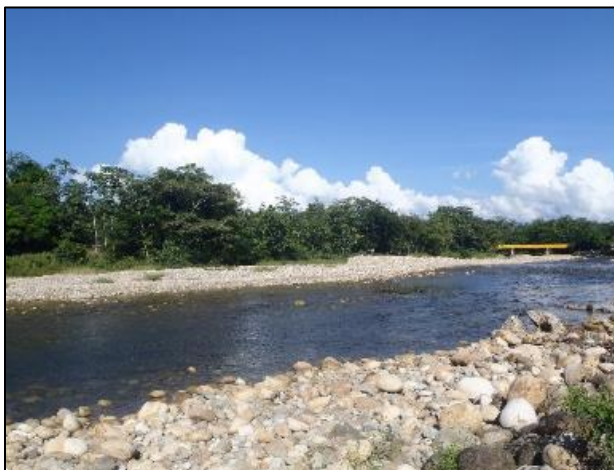
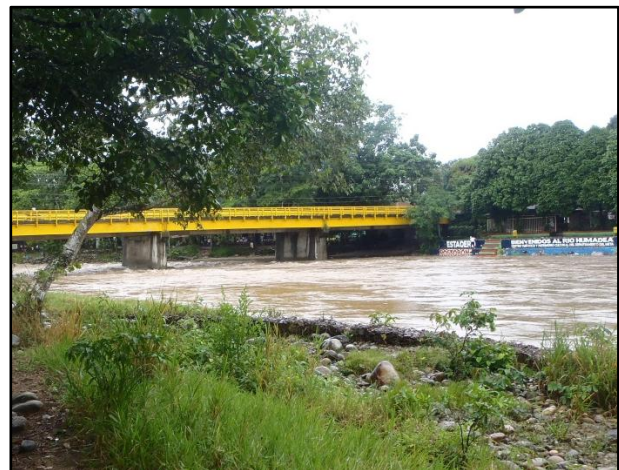
**Figure 22 Humadea bathing river during dry season (left) and after rainfall (right)**

Although the bathing area received many visitors during the whole year (mostly during weekends), it has one important particularity that may disqualify its potential. During the rain or after the rain the river has tendency to rapidly increase its water level to the point that water almost flood the area outside of the river channel (Figure 23). In just few seconds the river can become extremely dangerous with water flow similar to high level white water rafting rivers. There have been drowning incidents due to this extreme phenomenon. The unpredictability of the river is very high, because it is common that there was no rain in the area, but there were heavy rains in the mountains thus the water increase come completely unexpected.

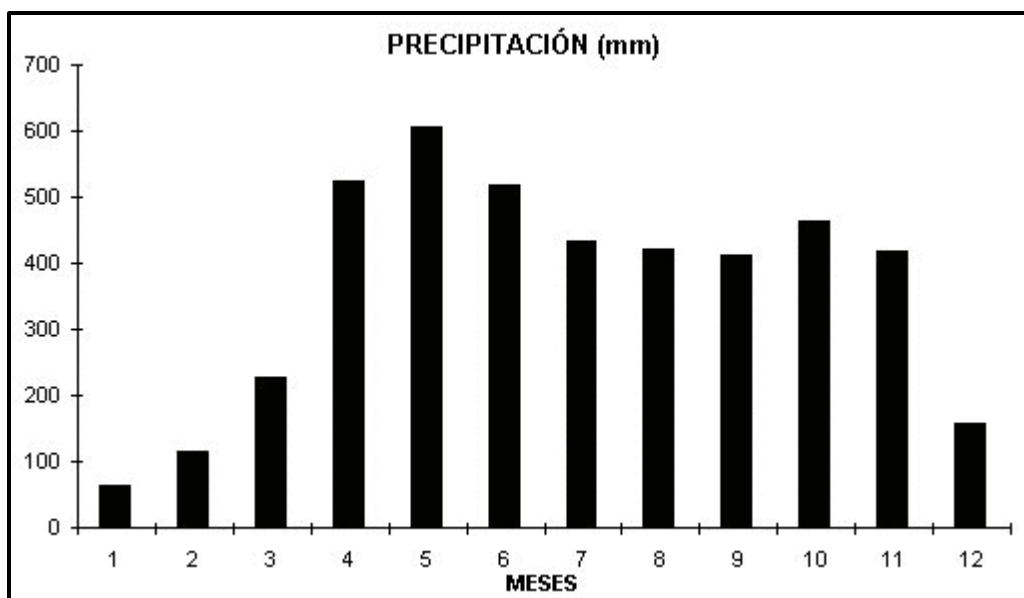
**Figure 24 Annual average rainfalls in Meta (mm per month).**

Due to the fact that the region is characterized by high rainfall seasonality, only the three months between December and March are considered to be dry (Figure 24), while during the rest of the year Meta received high amount of rain almost daily. Normally the rainy season is not a major disadvantageous factor for tourist destinations as the weather during the rainy days is often sunny for the most of the day with an hour or two of rainfall, normally at a very specific time of the day. However, in case of Meta the problem is of different nature. The water from the rainfall accumulates and flow from small strings into rivers, not only bringing contaminants from many different land based sources, but most importantly, the amount of water is so big that the water flow become dangerous and often rivers flood the area around the river's channel.

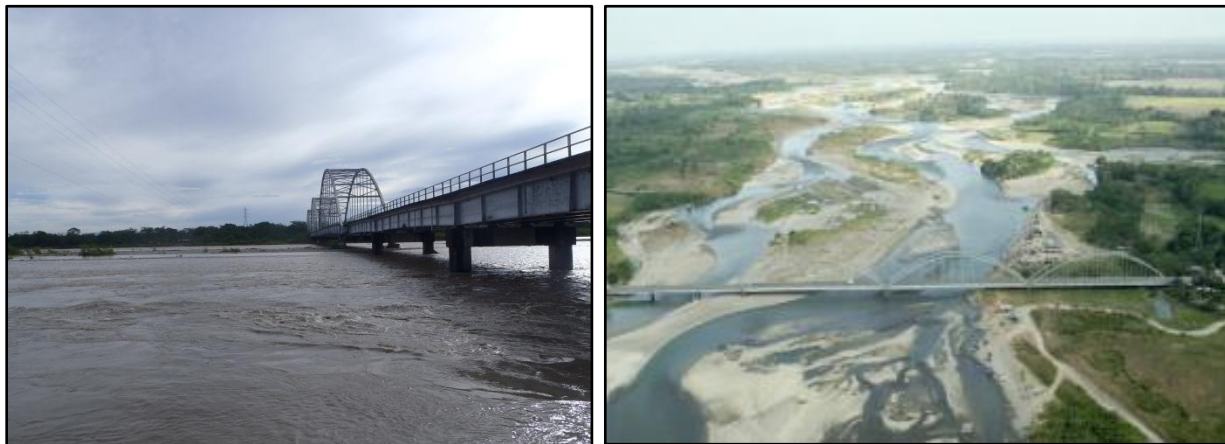
**Figure 25 Alcaravan bathing area during rainy season (left) and dry season (right).** During the rainy season the beaches disappear completely

A consequence of this phenomenon is mostly related to the space available and management of the beach itself in terms of zoning, accessibility and safety of the beach located in a new area. The solution to this problem is not very cost effective and it requires assessment of the beach after every bigger rainfall and changes to some management and safety aspects, maybe even physical infrastructure in some cases.

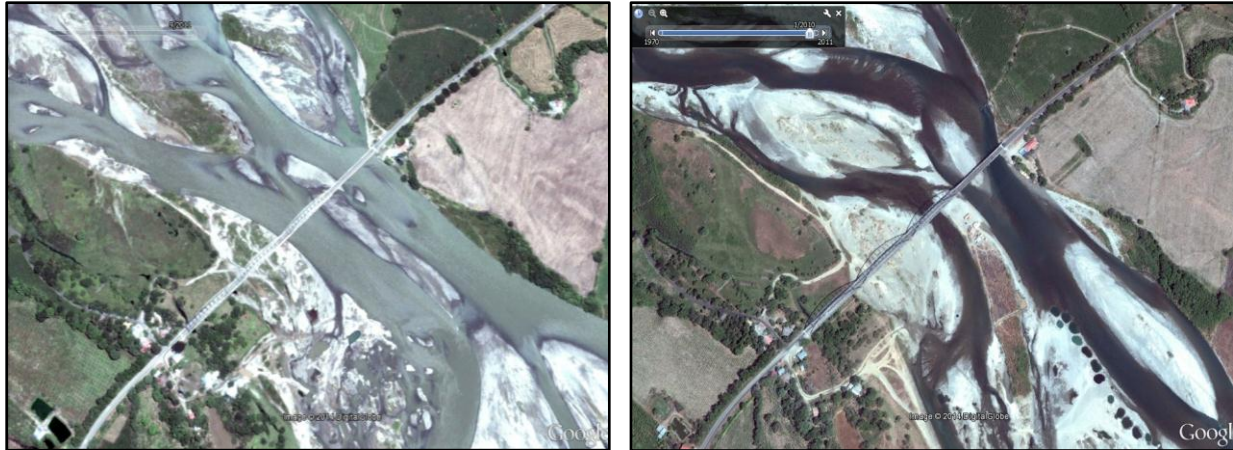
**Figure 26 Alcaravan bathing area in September 2011 (left) and January 2010 (right).** Although water level is very similar in both case, the river course changed noticeably. Source: Google Earth

Larger rivers move high volumes of water during the rainy months. As a result of this pattern, these rivers change their course by tens of meters every season (Figure 26), sometimes even it happens during one season. This has various management and safety consequences similar to the previous characteristic “seasonal availability of sandy beaches”. Additionally, there is an important issue of infrastructure that would have to be adjusted every year. As the course shifts, the beach location changes, sometimes it is possible that the beach happen to be far from the main infrastructure. The requirements about safe access points to the water, zoning and limitation of the bathing area would be very difficult and expensive to be met. Thus, a beach with this characteristic is not suitable for certification.

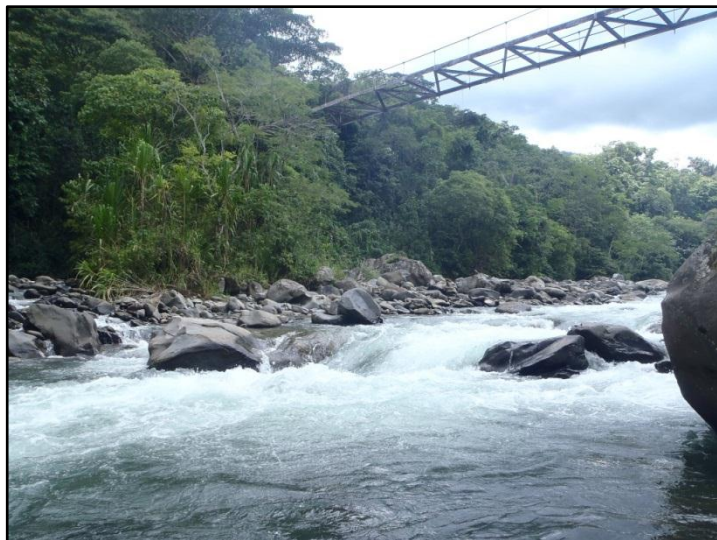
**Figure 27 Tonoa River**

Some rivers in Meta flow through mountainous and sloppy areas that force the current to increase its speed. In result, even during the dry season the river's current is too fast and violent for safe bathing. This characteristic disqualifies a bathing area as certifiable. There are solutions to this problem, but they require heavy engineering and thus investments. It is a risky solution as it is very likely that the return on investment will not be high enough.

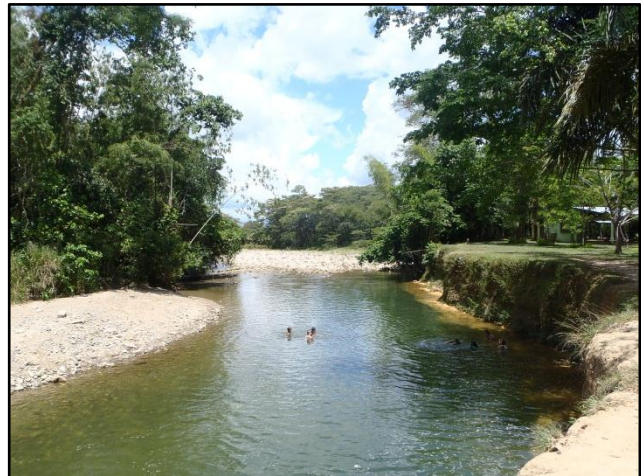
**Figure 28 Pozo Azul, an example of a river bathing area without negative pre-conditions**

The second group of river bathing areas that do not have aforementioned limitations for implementation of beach certifications is located on rather small rivers that move low volume of water and are not affected by heavy rainfalls. In this group only 2 out of 10 river bathing areas of Meta were classified. Both bathing areas are very small and located on a river bank that is much deeper than the rest of the river and thus have good conditions for swimming even during the dry season when the average water level outside the bathing area is lower than 50cm. Additionally, one of the two cases uses small dams made of river material as a solution for water level increase. The bathing areas of this type are more attractive, natural and the biggest limitation they have is little space available for bathing. In consequence, implementation of a beach certification, although possible, is very questionable in terms of financial feasibility and return on investment.
